**Margate Town Centre Regeneration**  
**Scenic Railway Fire Damaged**  
**Condition Survey**

**Job Number: B0853500B**

Client: Margate Town Centre Regeneration  
 Project: Scenic Railway  
 Title: Scenic Railway Condition Survey

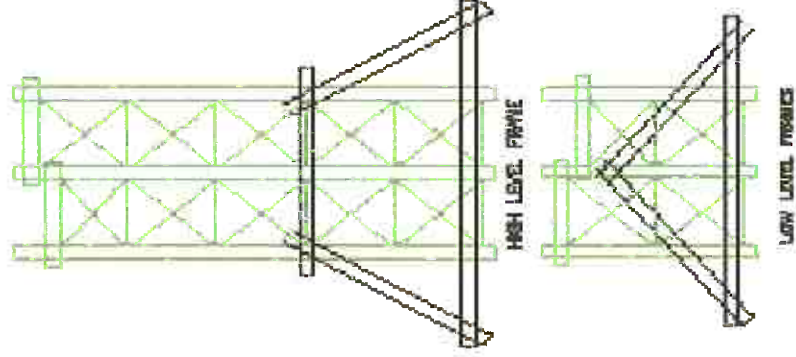
Typical sketches of temporary bracing details

To ensure the stability of the track structure it is recommended to temporarily provide additional braces to undamaged frames adjacent to the fire damaged sections and remove all damaged frames. These braces would provide additional stability to the end of the structure until the damaged sections are rebuilt.

It is recommended that frames A55,A31,A52 and B65 be reinforced and the damaged frames in between be removed.

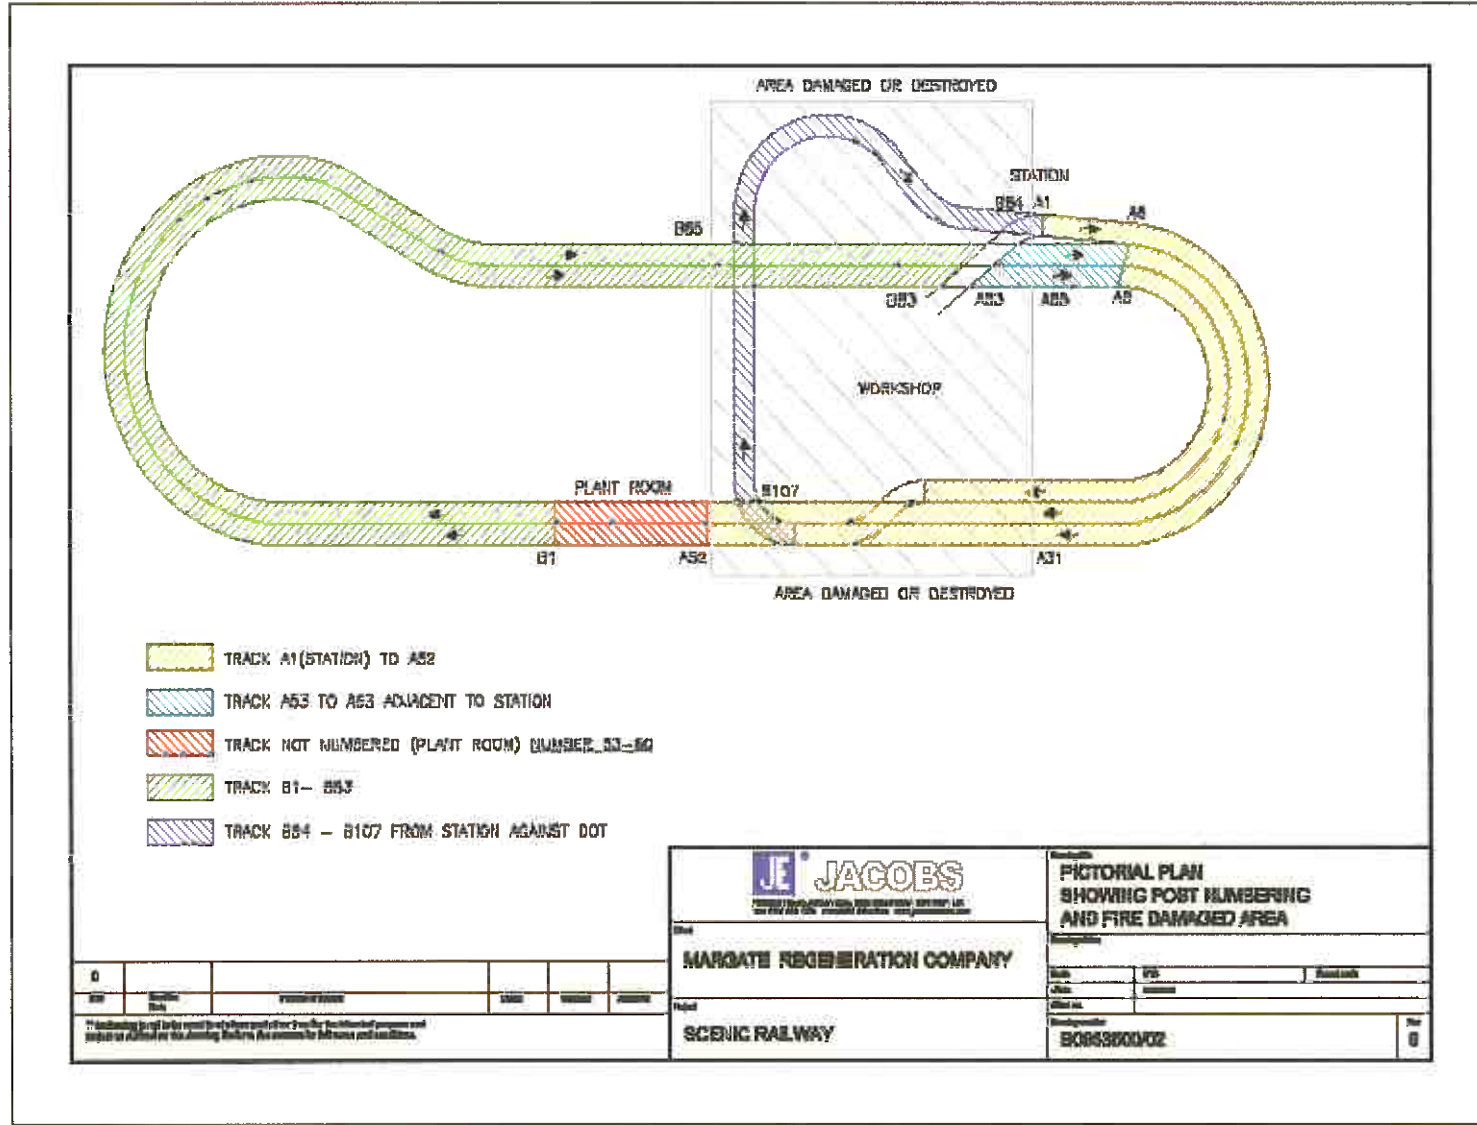
| | <b>Appendix A Drawing</b> | <b>4</b> |

Upon initial inspection a note was taken of the extent of the fire damage. The damage was limited to the following areas. (see sketch appendix A)

Workshop : Destroyed.

Station : 50% Damaged.

Track and Structure Damaged/Destroyed between frames:-

A31 to A52 Lift hills  
B65 to A55 track adjacent to station  
B84 to B107 run in to station

The track has also been damaged in the station to frame A1 and switch track from the workshop.
